Manhole Inspection Summary

Manhole # S15Q__006MH

Insp Date: **4/14/08 9:25 AM**

Location Address: **2717 wilkens ave**

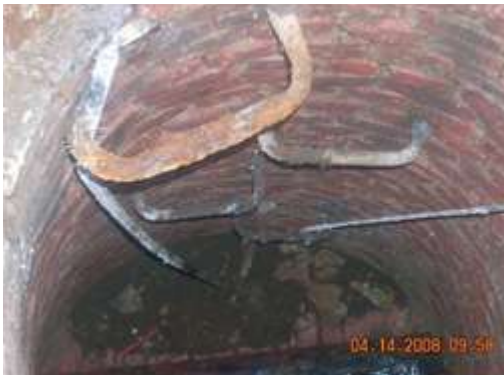
Defect 3

Steps Count: **4** Missing: **0** ☒ **Corroded**

corroded steps

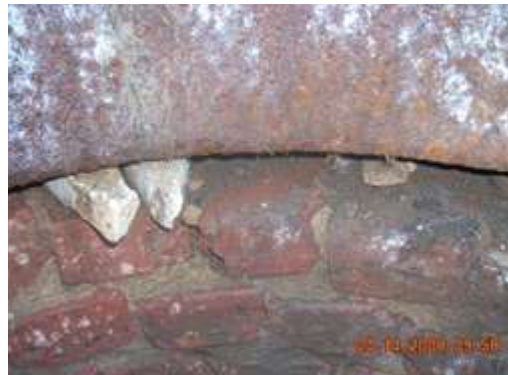
Defect 2

Chimney / Frame Adjustment ☒ Exists Material: **Brick** ☐ Parged Height: **2** (in.)

Condition: ☐ Sound ☐ Cracked ☐ Root Intrusion ☐ Loose Brick ☒ **Deteriorated**

deteriorated chimney

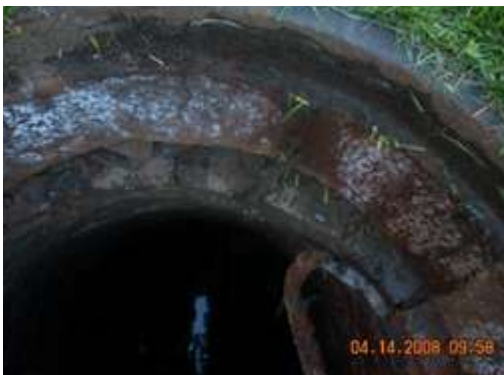
Defect 1

Frame Offset: **1.5** (in.) Condition: ☒ Sound ☐ Cracked ☐ Leaks

frame offset

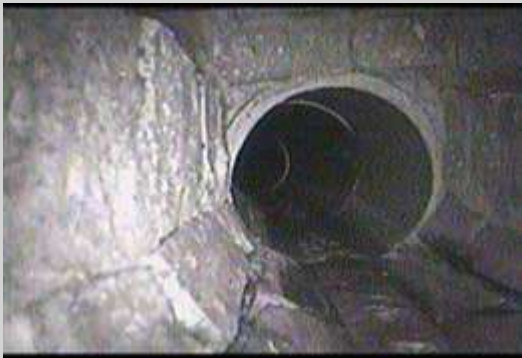
12 O'Clock Outflow

Pipe Height: **8.4** (in.) Rod and Bar (Angled)
Pipe Material: **Clay** ☐ Pipe Lined
Invert Depth: **8.30** (ft.) Flow Characteristics: **Slow**
Deposits: ☒ None ☐ Mud ☐ Sludge ☐ Debris ☐ Grease
Silt Depth: **0** (in.) Deposits Extent:
Infiltration: **None** Pipe Seal Cond: **Sound**

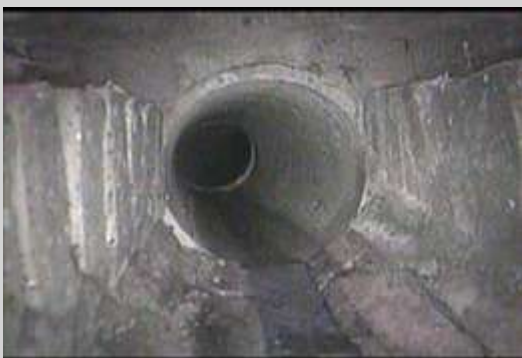
6 O'Clock Inflow

Pipe Height: **7.2** (in.) Rod and Bar (Angled)
Pipe Material: **Clay** ☐ Pipe Lined
Invert Depth: **8.09** (ft.) Flow Characteristics: **Slow**
Deposits: ☒ None ☐ Mud ☐ Sludge ☐ Debris ☐ Grease
Silt Depth: **0** (in.) Deposits Extent:
Infiltration: **None** Pipe Seal Cond: **Sound**

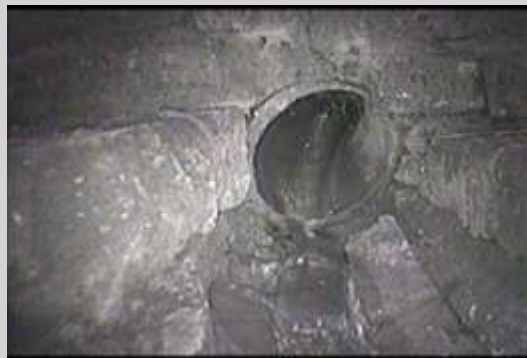
8 O'Clock Inflow

Pipe Height: **6** (in.) Rod and Bar (Angled)

Pipe Material: **Clay** ☐ Pipe Lined

Invert Depth: **7.89** (ft.) Flow Characteristics: **Slow**

Deposits: ☒ None ☐ Mud ☐ Sludge ☐ Debris ☐ Grease

Silt Depth: **0** (in.) Deposits Extent:

Infiltration: **None**

Pipe Seal Cond: **Sound**
